Refurbish pumping station shafts: Uncomplicated replacement of old equipment

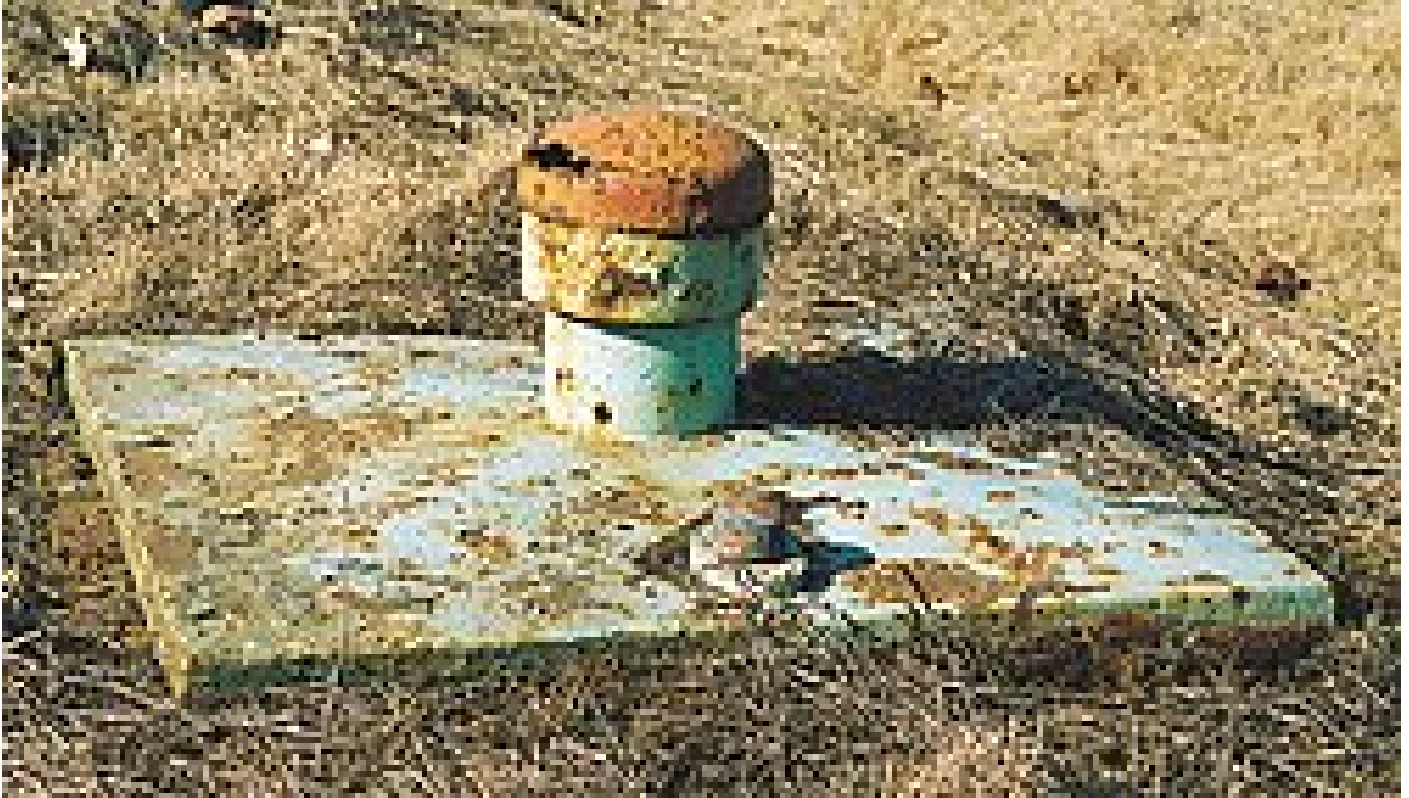
A frequent sight! The ravages of time are taking their toll!

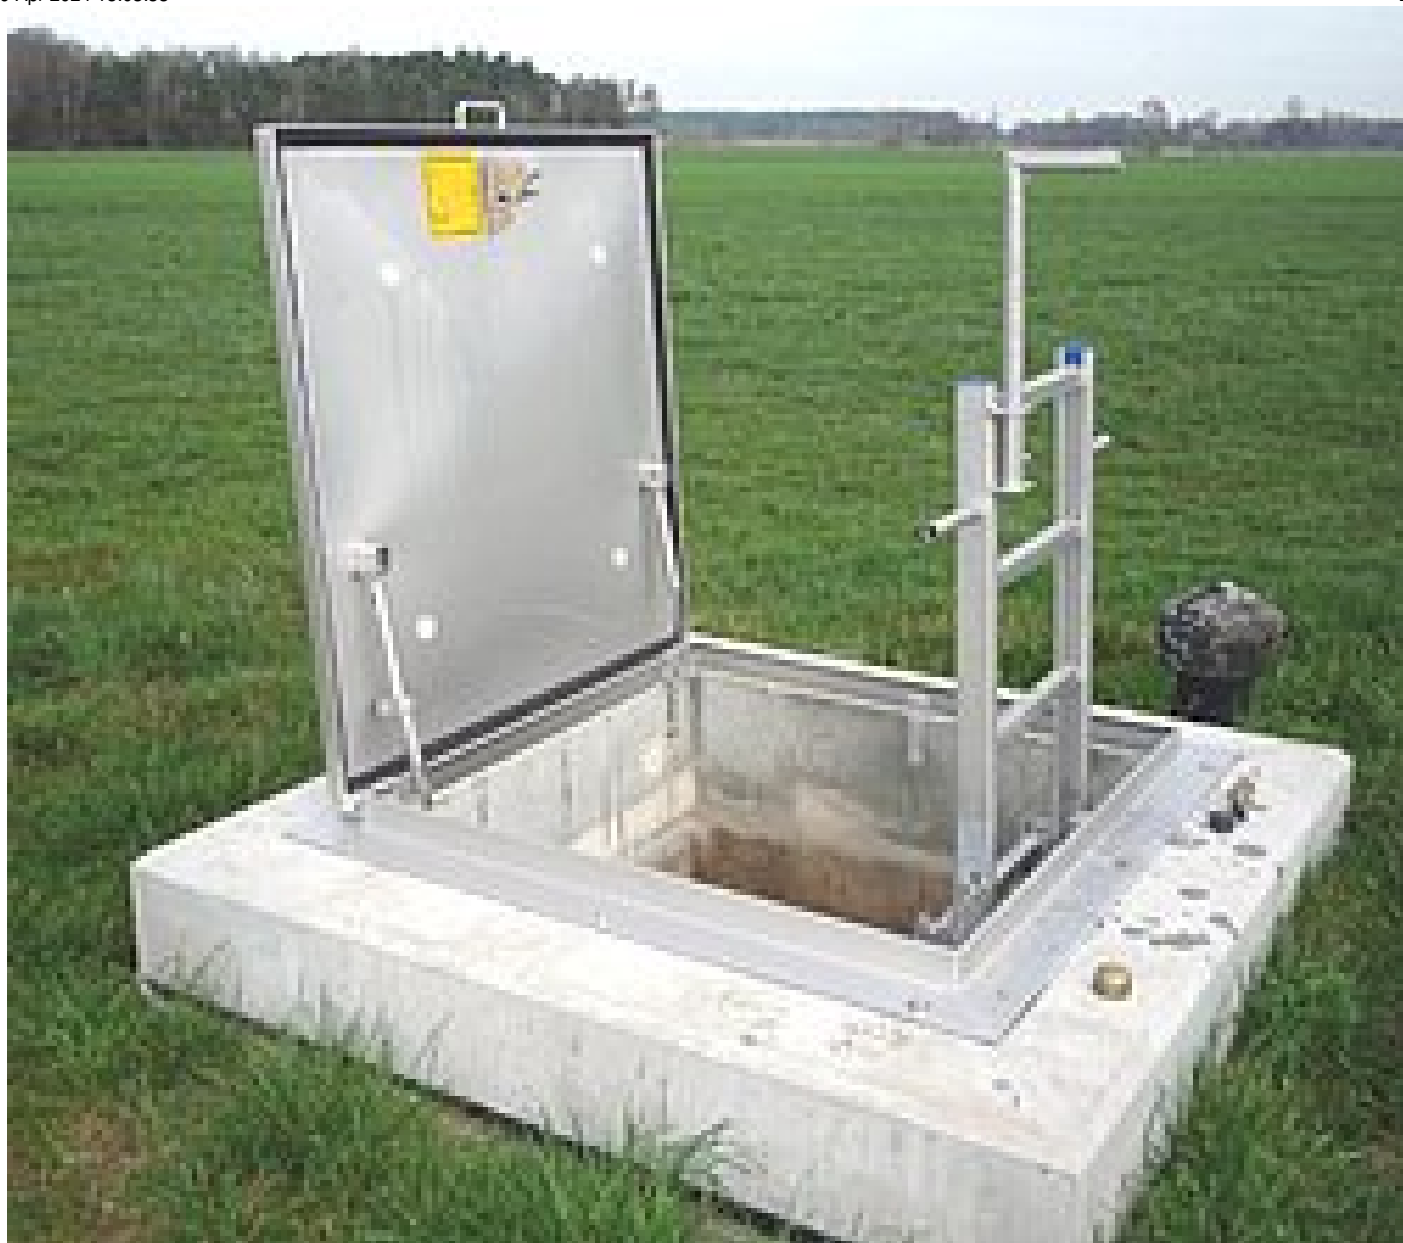
Safe equipment: manhole covers, safety access ladder and entrance aid

Completely made of stainless steel (1.4307 or 1.4404), acid treated in a pickling bath and passivated, custom-made to measure, options available according to customer's needs as attack-proof / security tested, flood-proof, backup-proof, load bearing (up to 40t) covers. We have the suitable cover for any of your applications!

Security tested to DIN EN 14396, DIN 19572, with CE label, completely made of stainless steel (1.4307 or 1.4404), acid-treated in a pickling bath and passivated, ladder with guard rail as fall protection, diverse types of entrance aids available.

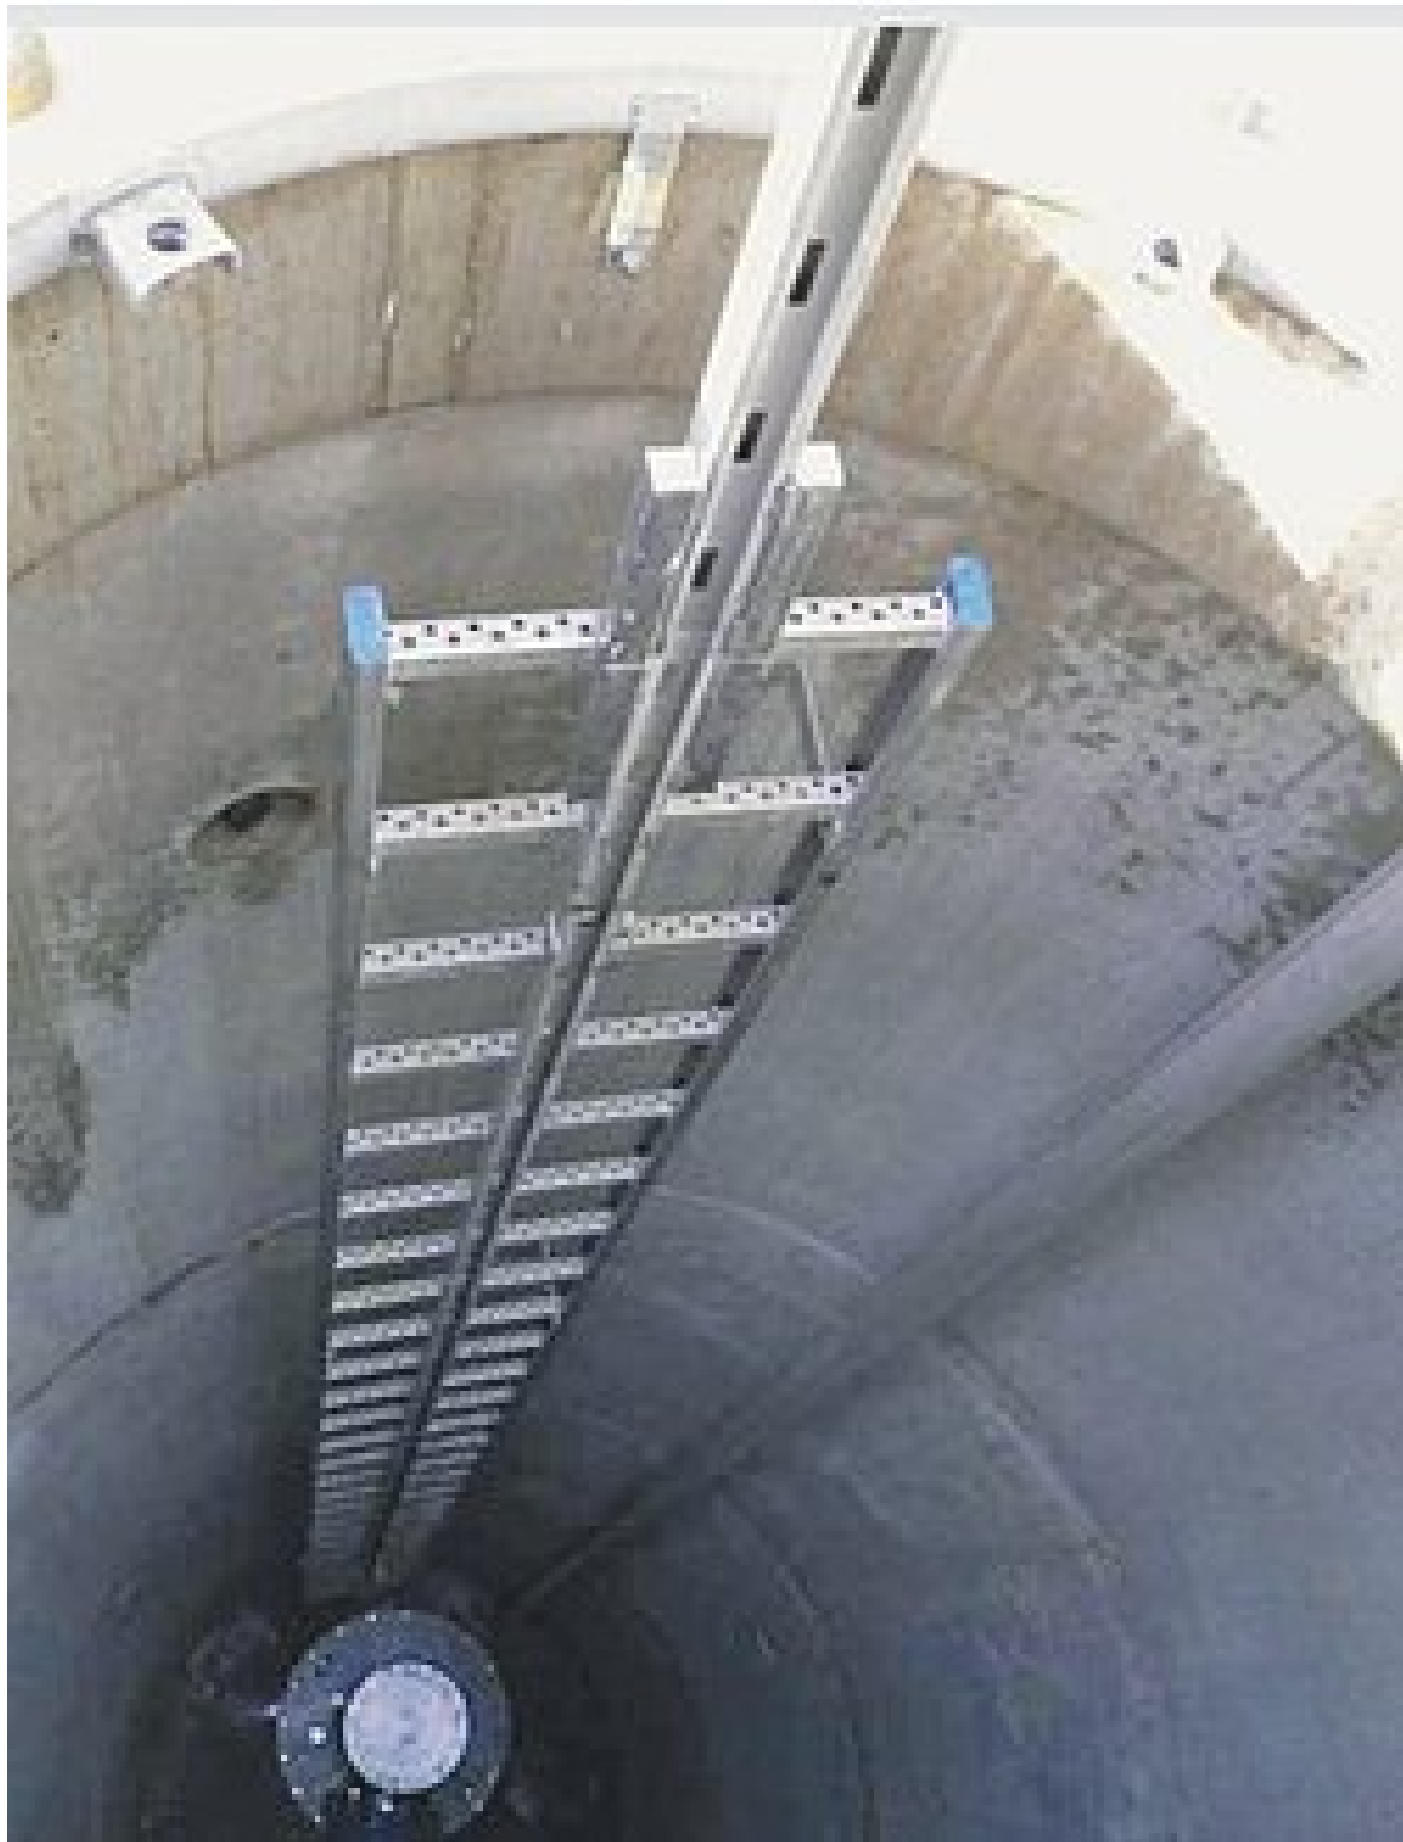
Safe access: ladder with safety guard rail
